Restoration of an Eko Viscount Reverb amplifier

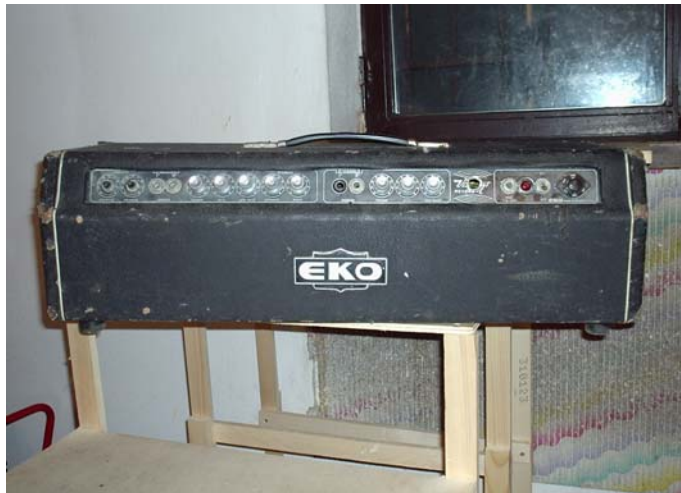
Front...

Some 18 years ago while I was throwing away some garbage in a junk yard I found this Eko Viscount Reverb laying in the mud. I saw the tubes inside and so I took it home thinking that sooner or later it might have become useful. A few months ago my 12 years old nephew felled in love with guitars and as a present for his birthday we all gave him a classic guitar. For the future he is thinking about an electric guitar. So after 18 years of waiting that old amplifier finally became useful!!! As you can imagine, when I took it from its storage it was a little dusty, I cleaned it and here are some pictures.

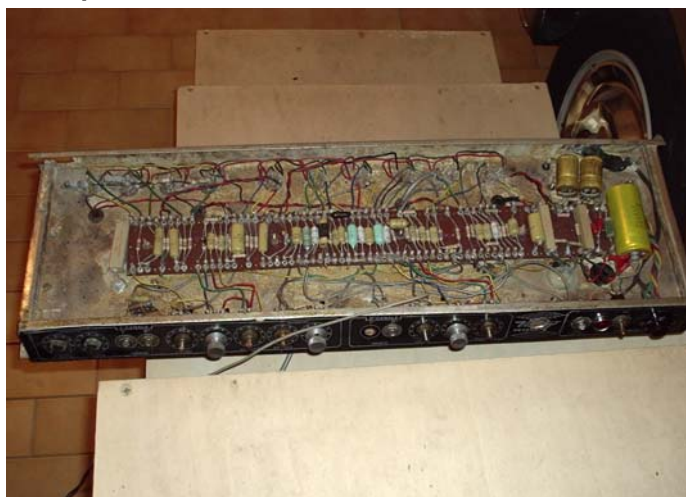
A couple of views of the electronics

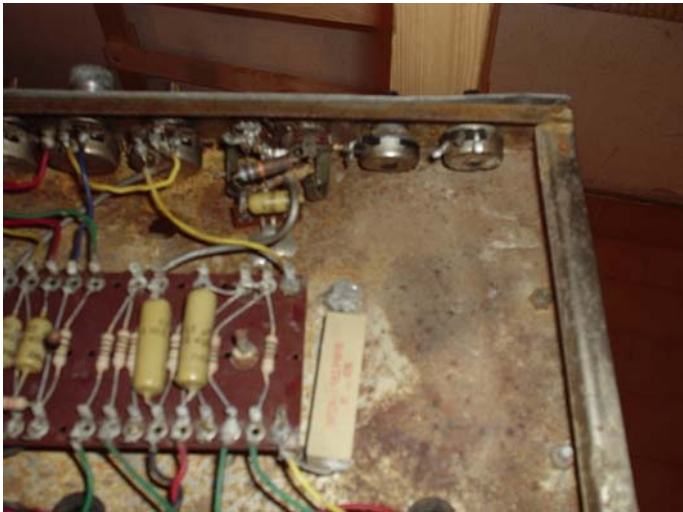
Controls...

In this amp unfortunately all the wirings of the vibrato circuit have been cut away, only the tube and the components have been left on the board... luckily!!! Here are some close views of channel 1 input and of the two vibrato controls wired to the surrounding air.

The two vibrato controls are not original, probably they have been changed because the original ones did not work anymore, but this seems strange to me, I would bet that the volume control, that are still the original ones, would fail sooner than these. Otherwise they have been changed because another electronic circuit was fitted inside this amp. This possibility seems to be much closer to reality also due to some modifications done to the chassis (holes and cuts). In this case I suppose that even the values of the controls fitted in the amp are not the correct ones.

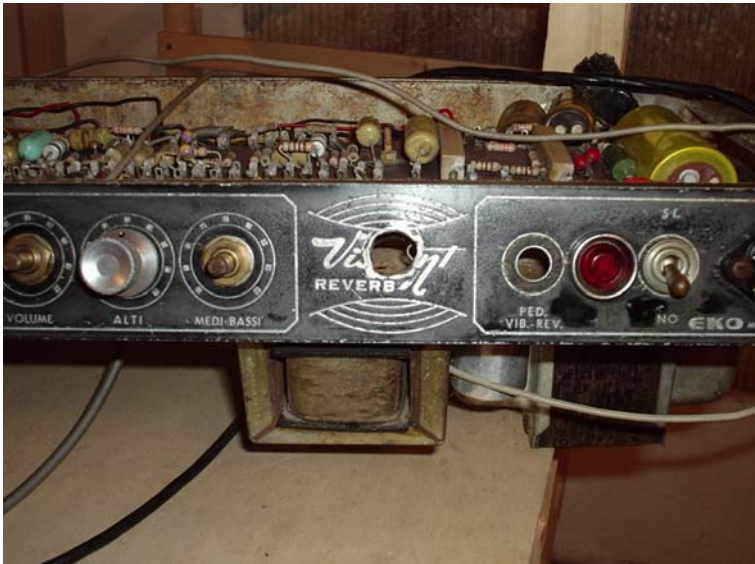
A NICE HOLE!

And now something about cosmetics. Someone decided to add another input jack and then he/she removed it leaving a very nice hole just in the middle of the Viscount logo. Really attractive, isn't it? I'll try to reproduce the missing part.

This would have not been a tough work if that horrible hole would have not been drilled in to this badge.

Anyway, after a couple of nightmares I came to a solution. First of all I took the faded black paint back to its original black color. I used a thin polishing compound, in the next picture you can see the difference between the untreated (left) and the treated (right) paint.

Now it's time to fix the hole. I cut a round piece of aluminum sheet of the exact measure and shape of the hole, with a hammer I fixed it in the hole then I finished the job with some resin. I chose this solution because there was no way to weld a sheet without damaging the paint and the writings around the hole. Here is the result, still to be painted.

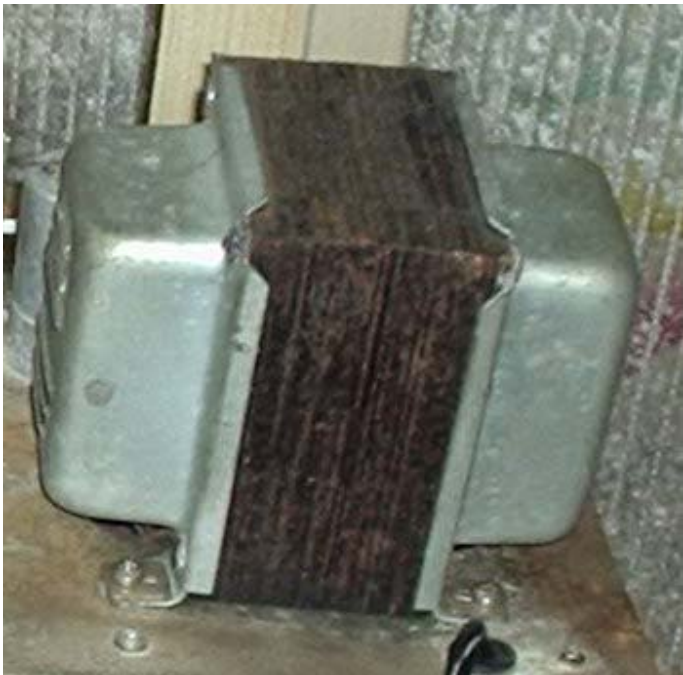
That's how it looked before the plastic surgery.

No way! It can't stay that way! I replaced and insulated those wires.

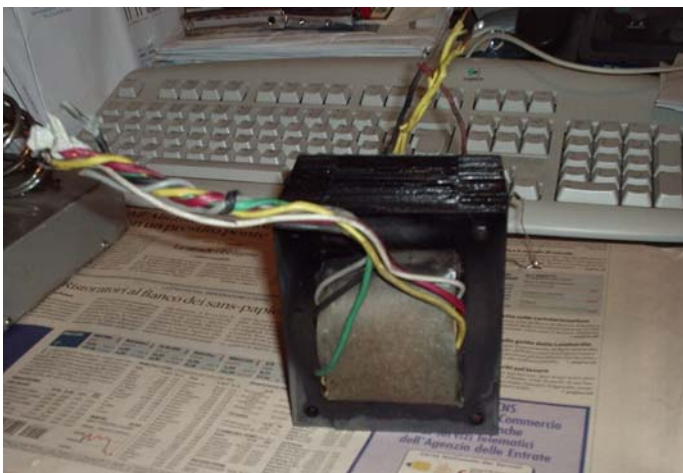
After removing the case I had a surprise: the primary winding wires are OK...

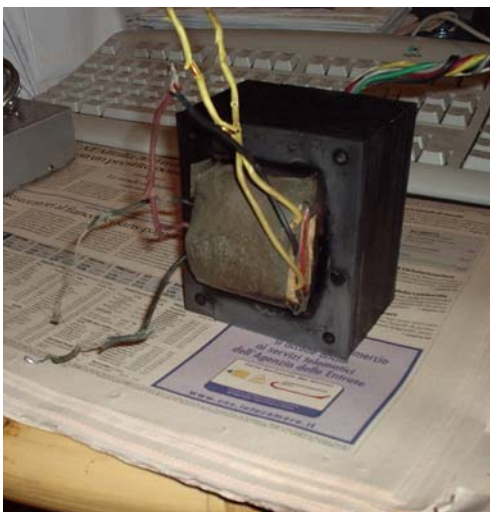
... but not those of the secondary windings: look at the high voltage wires (two green and one red) almost completely without insulation! Also the low voltage wires (the yellow ones) are not in good condition.

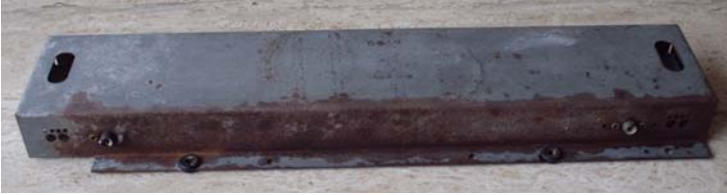
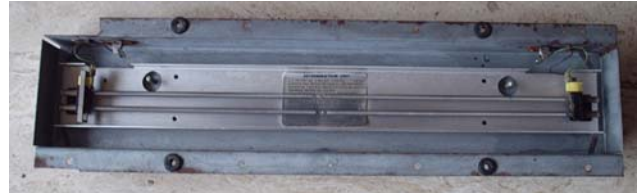
Before...

This is a Gibbs/Hammond type 4 spring reverberation unit, unfortunately at the moment I have no other information available about the exact model. The outside did not look nice at all, but fortunately the inside was in very good shape with no rust on the springs. I mechanically removed the rust with sand paper, then I painted the case with a zinc based paint and then I changed the RCA pins and the rubber noise insulators.

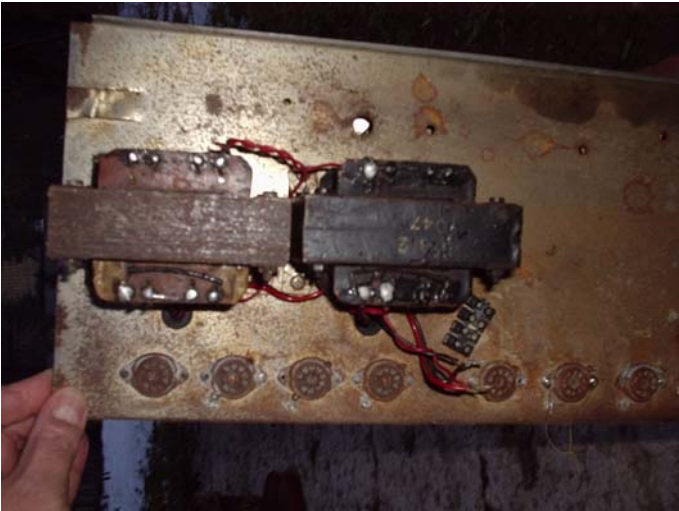
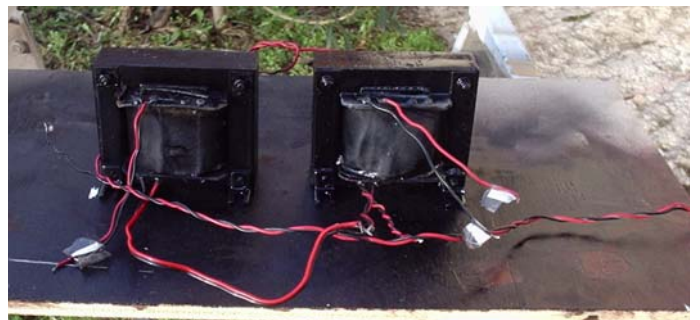
OUTPUT TRANSFORMERS

At the beginning it looked like no big job was necessary for them, only some cleaning and black paint, and that's what I did.

But when I switched the amplifier on I realized they had problems because I could not get anything more than a 9W. I tried first changing the power tubes, I swapped 2 new couples but I still could not get any further. Everything seemed fine, but it wasn't. After 30 minutes of measurements I decided to retest the transformers and I found that in both transformers one of the primary windings (there are four in each transformer) was interrupted. I fixed them but when I powered the amp

again another primary winding blew up. Probably in all these years of far from perfect storage the insulating paint got damaged and the wires oxidized in some points, it was not possible to try to fix them again. I bought a new couple from an artisan in Milan specialized in transformers. By the way, I searched for the original part and it seems to be a Philips PK 508 12 (15W output power, 7 Ohm secondary, 8 KOhm plate to plate). It might be useful to attach the winding specifications of the original output transformer that should be common to all Eko production of the late sixties (Zodiac, Valet, Duke, Herald, Prince and of course Viscount) employing a push-pull of EL84 in the output stage.

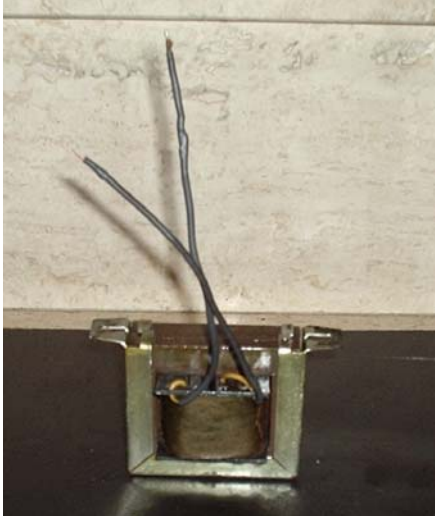
INDUCTOR

Another fast and easy job: some cleaning, light rust removal plus transparent and insulating paint to avoid future rust. The insulation of the two wires was broken in some points, I fixed it with heat-shrinkable tube.

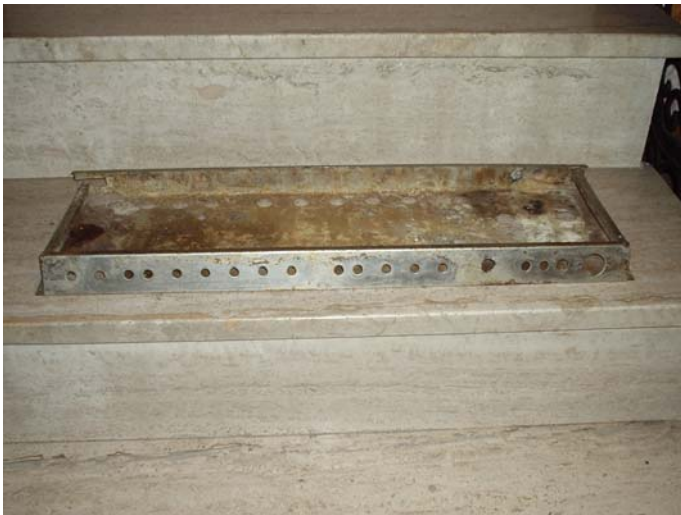
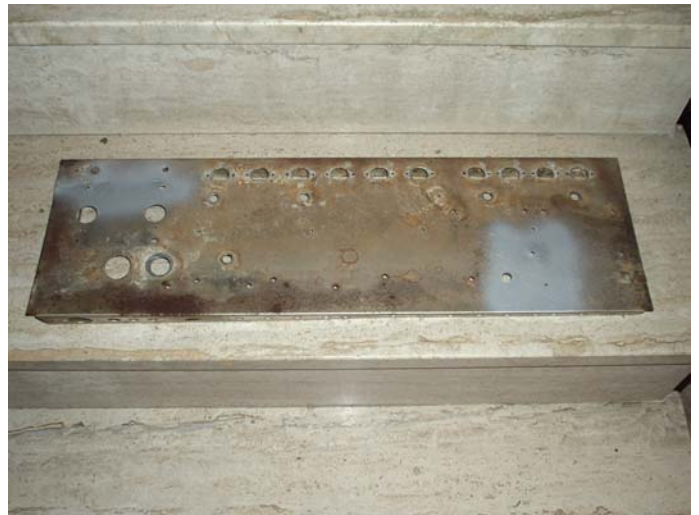
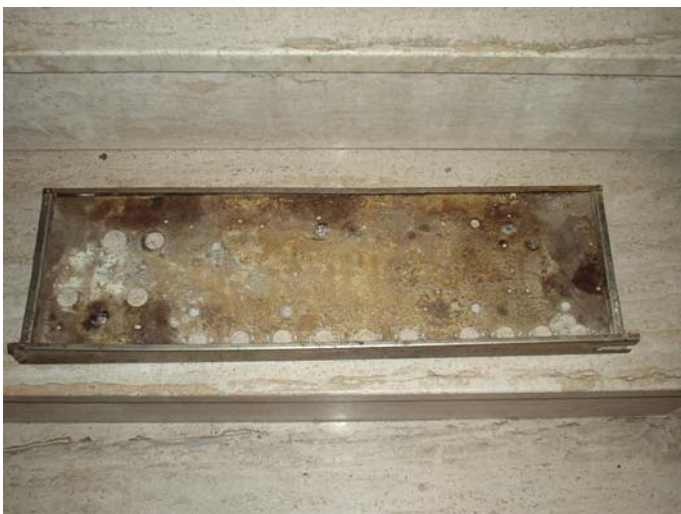
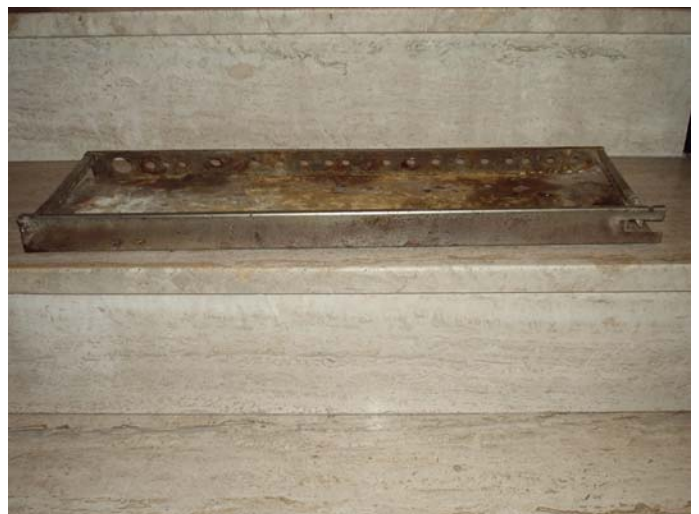
CHASSIS

The case and the chassis restorations are the biggest jobs of this project. First of all I removed all the electronics from the chassis: components board, front panel jacks, potentiometers, transformers, inductor and the two big electrolytic capacitors. Here are some pictures of the naked chassis.

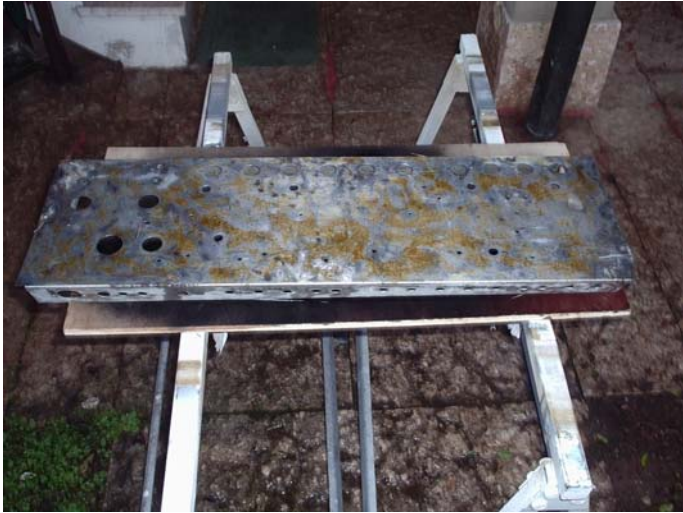
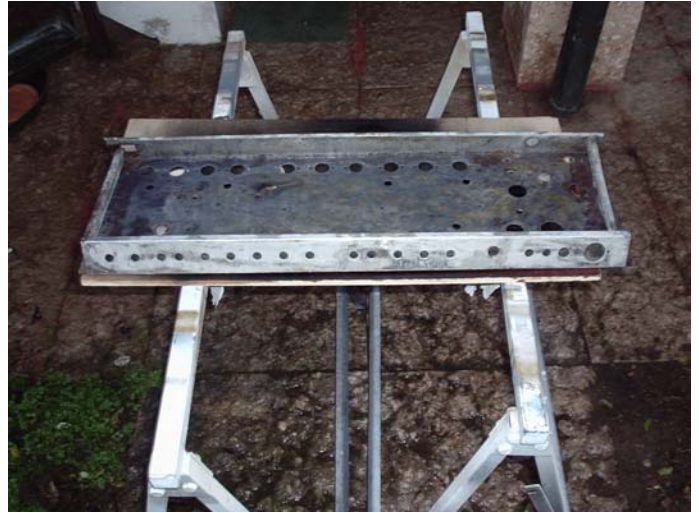
The chassis was slightly bent in some places, probably because of the heat coming from the power transformer and from the output tubes or because of some hits during transports. I straightened it and then I removed the rust, first mechanically (sand paper) and then chemically with a first bath in phosphoric acid, also useful for rust proofing.

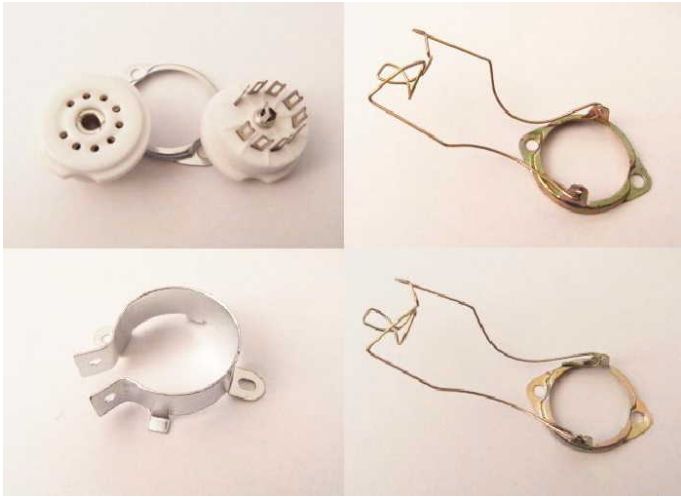
The chassis is now almost ready for the final work. One electrolytic capacitor needs a larger hole to fit its pins and four more holes for the clamps' screws of both capacitors. The original sockets are in such a bad condition that all need to be replaced: all retainers are missing and the silvered contacts have no more silver attached to them, only thick oxidation and rust. Sockets identical to the original ones (noval, bakelite, chassis mount with retainers) are no longer available, there are only the ceramic ones. I chose the type with normal contacts, because the gold plated ones have too little gold on them and this causes more problems than those the plating is supposed to solve.

The new sockets need larger holes because they are bigger than the original ones and, due to the different orientation of the pins, new holes for the screws need to be drilled.

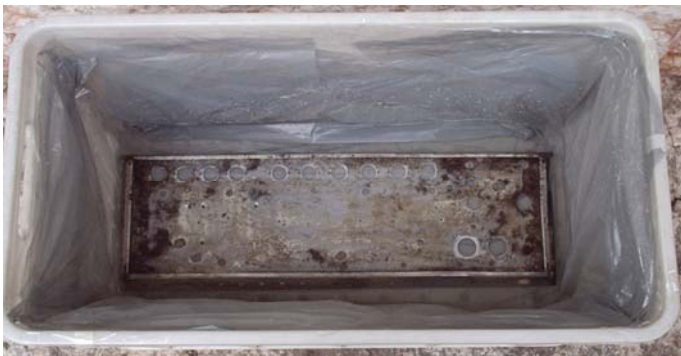
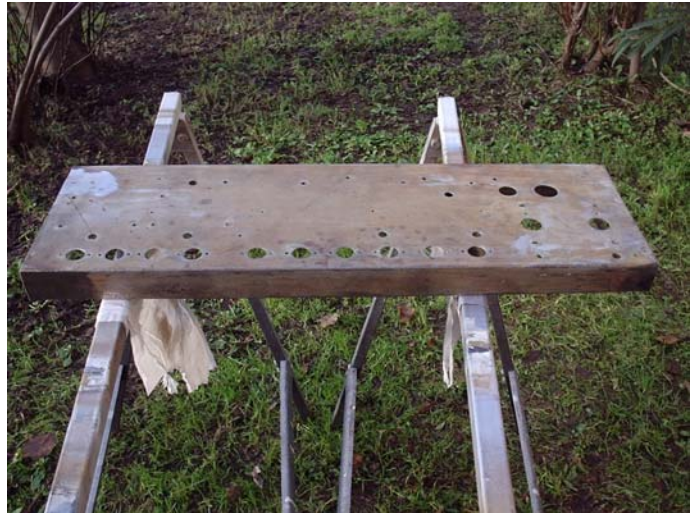
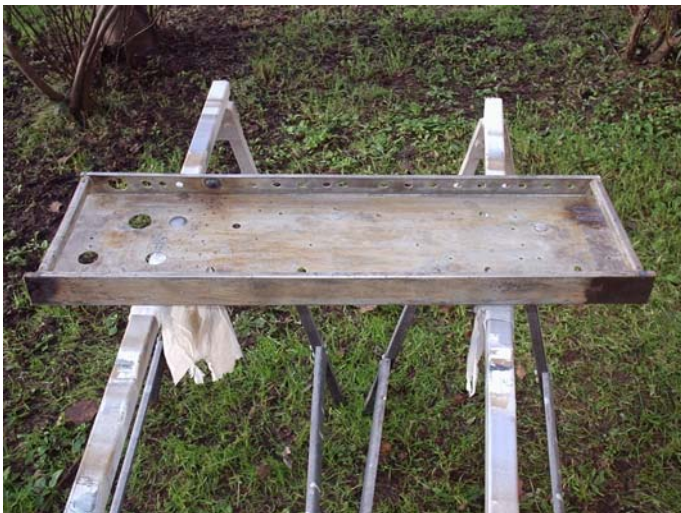
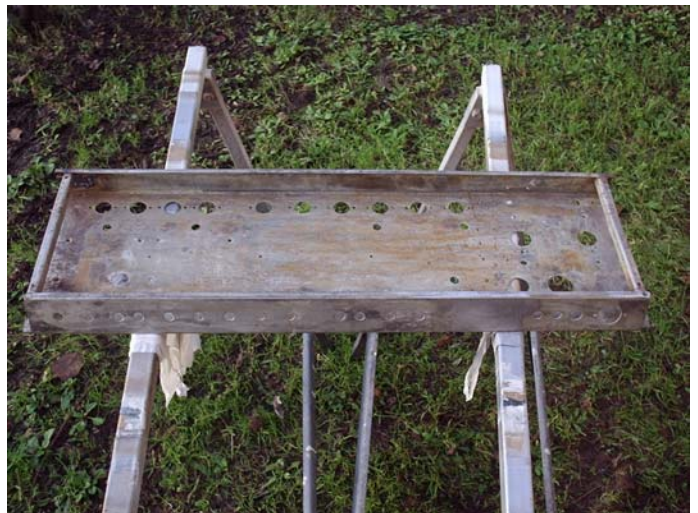
I'm taking the chassis back to the blacksmith to complete this job. After the restyling for further rust removal & proofing the chassis will spend some more hours in a phosphoric acid bath and it will be ready for the final finishing.

Originally the chassis was lightly chromed, but now all the chrome has been detached from it because of rust, bends & cuts, welds and holes enlargements. I think that the final look would have been horrible with the chrome back again and so the cost would not be justified. I painted it with a zinc based paint exactly as I've done with the power transformer and with the reverberation unit.

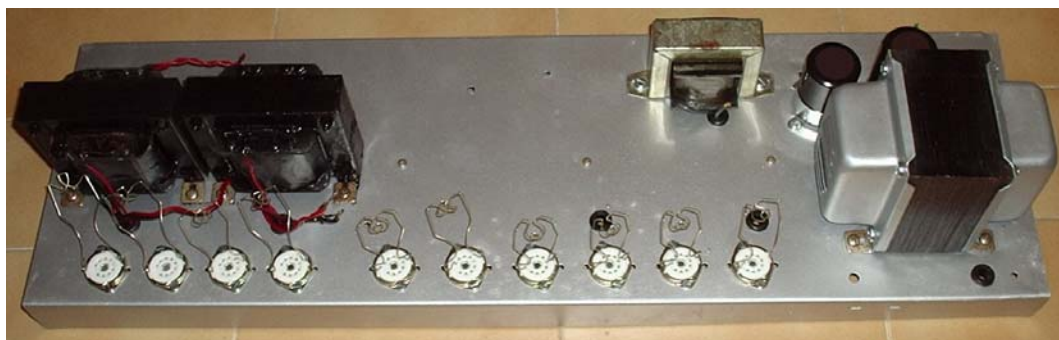
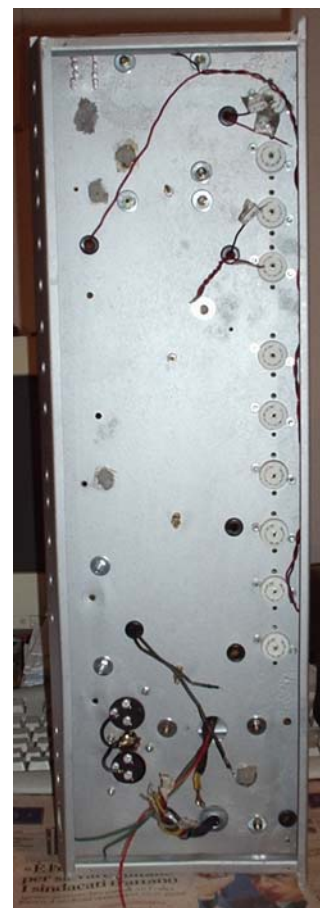
After the painting work I started reinstalling the components: irons, two big electrolytic capacitors and tube sockets with retainers.

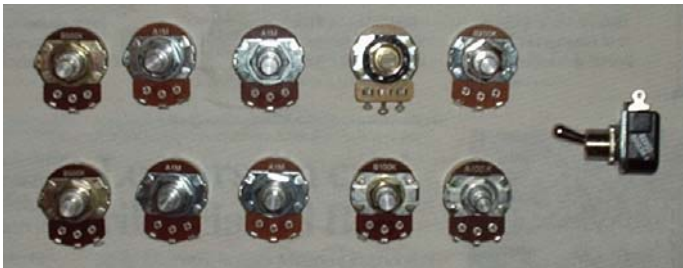
The potentiometers are all Alpha apart for one CTS for the vibrato speed control. I'm going to change the mains switch too because in the original one part of the chrome has gone away.

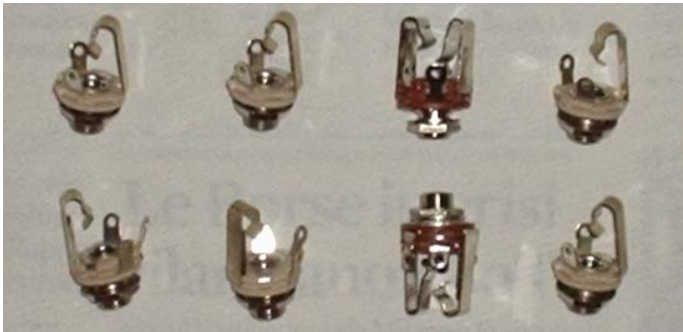
The jacks are all Switchcraft apart from the footswitch and the phones ones. You can foresee some add-ons I've already planned: this amp will have phones output and two jacks for the loudspeakers, obviously plugging the phones in will disable the loudspeakers, it's a very little and super fast add-on that will make in home use more comfortable.

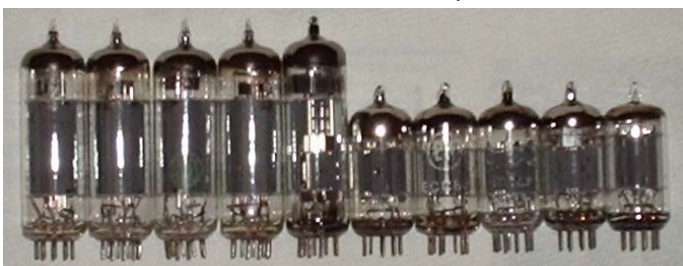
- three Telefunken ECC83 (one with long plates);
- one Siemens ECC83;
- one EK ECC83, it tested much stronger than the others and will be installed as the driver for the output stage;
- one unknown brand ECL86;
- four EL84/6P14P Reflector military Russian tubes.

- ECC83 within $\pm 3\%$ for each section of each tube, $\pm 5\%$ between tubes;
- EL84 $\pm 5\%$ between tubes.

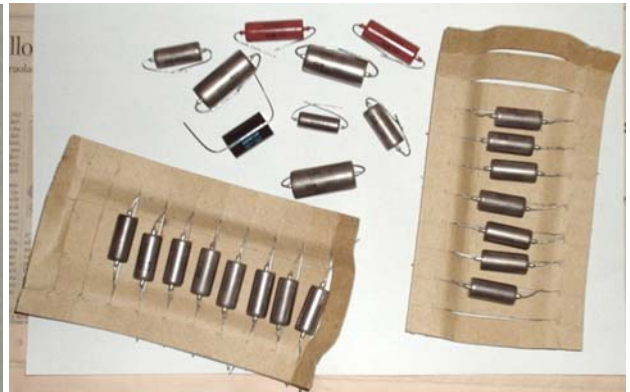
CIRCUIT BOARD

It's time to lay my hands on the electronic circuit board! While reverse engineering this amp I spent some time in testing all the resistors to place an order for all the electronic components. Apart from the "mustard" capacitors that will be tested with power applied to the amplifier, electrolytic capacitors, small capacitors (56pF, 100pF and 470pF), potentiometers, solid state diodes, shielded cables and out of tolerance resistors are all going to be replaced. Because of the increased filter capacitor values I decided to employ bigger diodes: BY255 rated 1300V 3A, stronger than the original BY127 rated 1250V 1A.

I decided also to replace the original coupling capacitors in the critical points: the reverberation unit driver and the output tubes. The others are not critical because, in case of leakage the maximum current flowing in the following tube is limited by both the anode and cathode resistors that have high values. If the coupling capacitor of the reverberation unit driver fails, the input stage of the reverberation unit would be blown away. On the other side if one of the coupling capacitors of the output tubes (those before the control grids) fails the current in two output tubes would raise dramatically leading to sure damage of the tubes and, in worst cases, of the output transformer too. These are definitely issues I want to avoid, so here we have brand new Audyn Cap capacitors waiting to be installed on the circuit board and also military grade paper in oil (PIO) and aluminum-teflon capacitors.

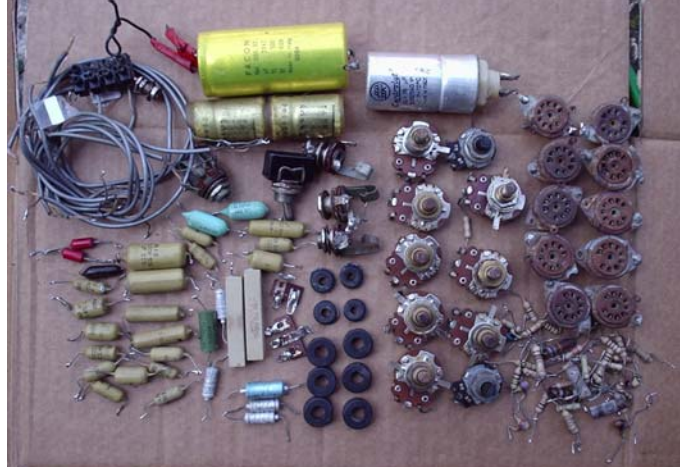
... and everything that was replaced!

Some jobs I've done to the electronics were more preventive than actually fixing. The substitution of the electrolytic capacitors is a good habit when you deal with vintage electronics and high voltages. I found some resistors out of tolerance (>15%) and other three were interrupted. Both the resistors of the reverberation unit driver had greater values leading to a lower gain and higher output impedance of this amplification stage; one resistor of the phase inverter of the power amplifier was interrupted so only a half of the output stage worked and the distortion was high. The most interesting thing was the interrupted 4.7M resistor of the neon driver of the vibrato effect: this prevented the circuit from working. This failure probably convinced the previous owner to internally install another circuit of which the only clue was the two different potentiometers installed in the chassis. Other issues came from the potentiometers. Although they were not interrupted and had a good mechanical movement their values were all out of specs. The 1M ones (volume and bass+mids) were between 800K and 1.3M and the 500K ones (treble) were about 800K, this would have prevented a good performance of the tone control network. Front panel jacks and tube sockets were far beyond any possible restoration, new ones were a must! All these issues may look like a disaster and in fact it almost is, but let's not forget where I found this amp (junk yard) and where it has been stored for 18 years: in a loft, humid, cold in winter and awfully hot in summer, definitely not a proper place for electronic equipment!

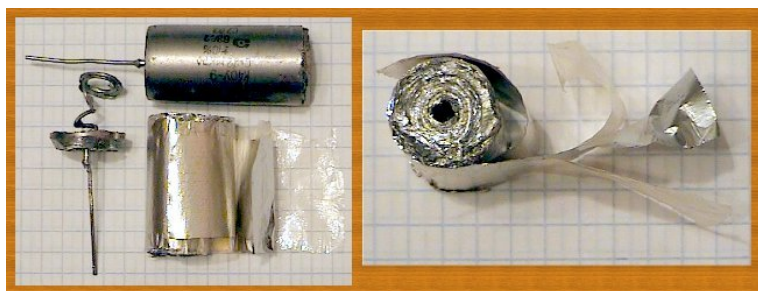
I could have stopped at this point but it would not have been good enough for me. The original tubes were in still good shape but I decided to change them with selected and matched ones, all apart from the ECL86. At this point my aim to have almost perfect electronics took control of my mind. Those 40 years old coupling capacitors made me think a lot, I was worried that sooner or later a failure would have been experienced. I have looked for some time for capacitors of the same brand, the so called "Mullard mustard", but I could only find used or NOS ones at high prices. In my opinion NOS is fine but it depends what we are referring to. It is for tubes, transformers, knobs, etc. but when we talk about passive components such as resistors and capacitors the scenario changes... dramatically! The characteristics of this type of components are not static, they change as time goes by. This is due to use, storage, humidity, temperature and age. The degree of such changes also depends on the quality of the components, meaning for example if they were produced according to standard specifications or to military ones. A NOS capacitor that has been properly stored, after many years might be like new. Unfortunately nobody can guarantee the "proper storage". A NOS capacitor that for example has been stored in a humid place with high changes of temperature might have capacitance out of tolerance, current leakings because the internal structure oxidized or it might fail after a few hours of use. Keeping all this in mind I decided to change the remaining capacitors too. I decided to install components with sonic characteristics similar to the original ones. The usual metalized film (MKP, MKT and so on) are of course out of the game; no NOS Mullard mustards stored in a nice "nobody knows where"... so what else? The answer is quite simple: military grade PIO russian capacitors, but only aluminum foil, no metalized paper, so I chose the K40Y-9 (aluminum-paper-oil) and the K72P-6 (aluminum-teflon) types, probably among the best capacitors for sonic performance. And here is their internal structure.

They are NOS... so what about what I've just written??? Well, first of all they are all military specs; they are air tight because glass sealed, so no air can go inside; they come from military surplus so there are many many more chances that they have been properly stored than for those "found in the shop of an old TV technician that passed away" and, last but not least, the ones I bought have been made in the late '80s or early '90s, not 20 or 30 years earlier. This, in my honest opinion, is a huge difference and a good guarantee of many years of trouble free service. The only 220nF MKT Audyn Cap are the coupling capacitor of the reverberation unit and the one in the negative feedback loop.

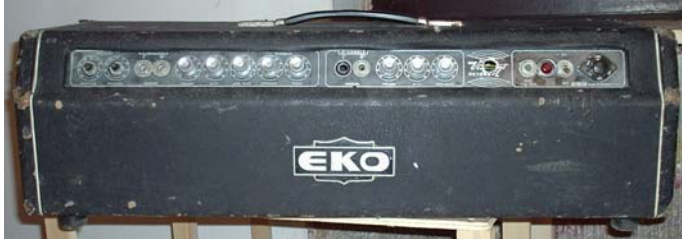
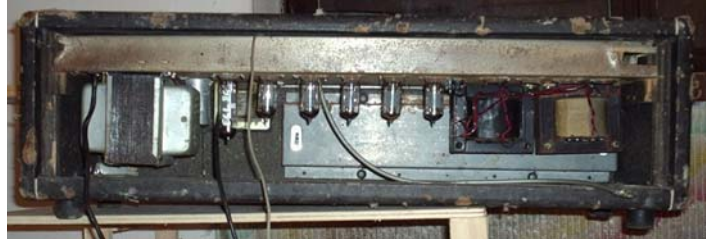
Now that the work on the electronics is finished it's time to take care of the outside. The tolex was beyond restoration, there was no way to get it in a comparable shape of what will be inside.

First step is to remove the old tolex without damaging it in order to have cutting guidelines for the new pieces.

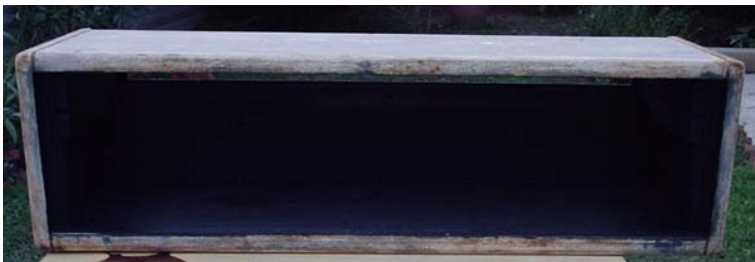
Some black paint inside before the "sticky job".

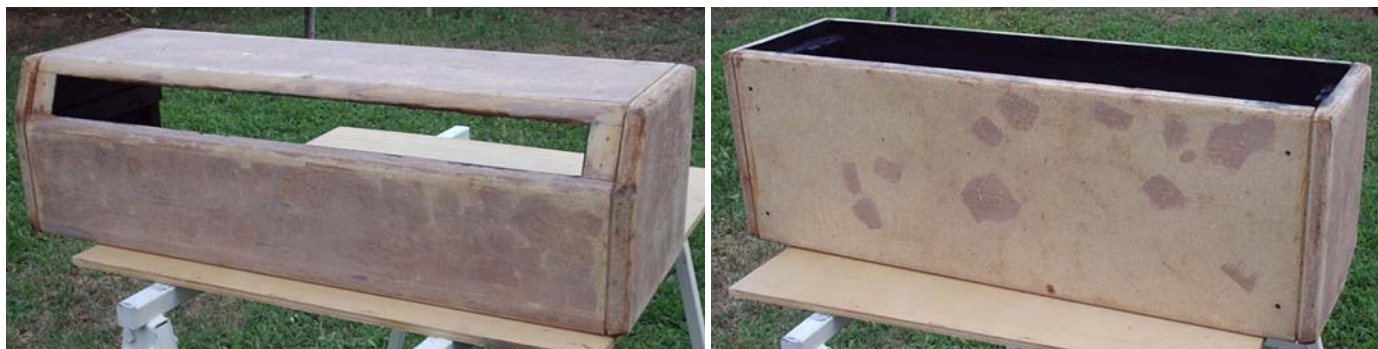
The result just before applying glue and tolex.

Then it is the cabinet turn: I removed the old glue and filled all voids caused by use, cigarettes (!) and water with a wood filler, then I smoothed the surfaces with sand paper. The same for any other irregularity in the surface or edges, such as small gaps in box joints. The top of the cabinet was slightly bent, this is how I got it almost straight again.

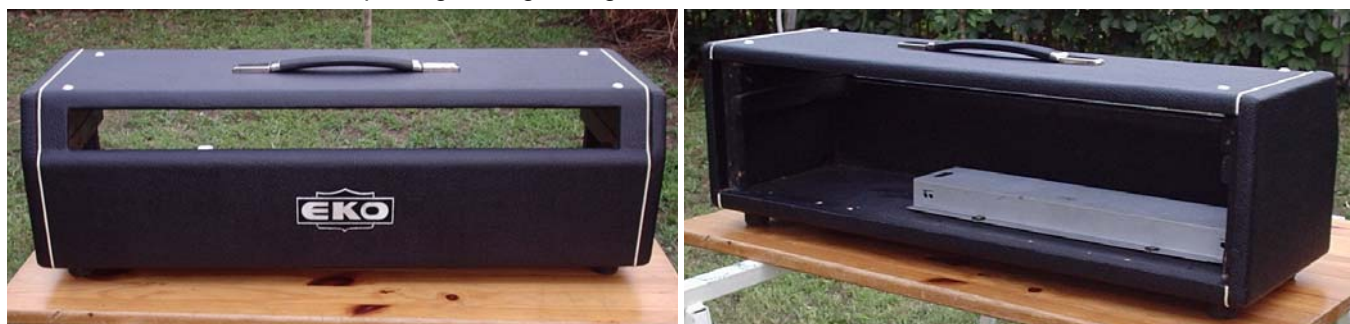
And here is the final result after replacing the logo badge, handle and feet.

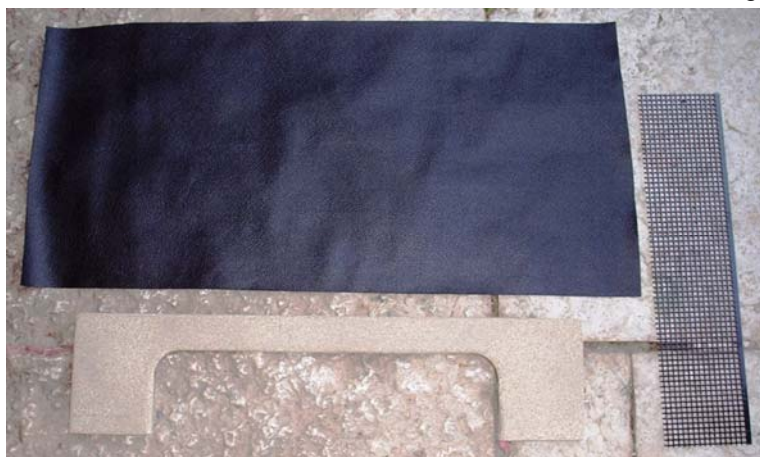
I had also to rebuild the back side cover because it was missing. Here you can see the pieces...

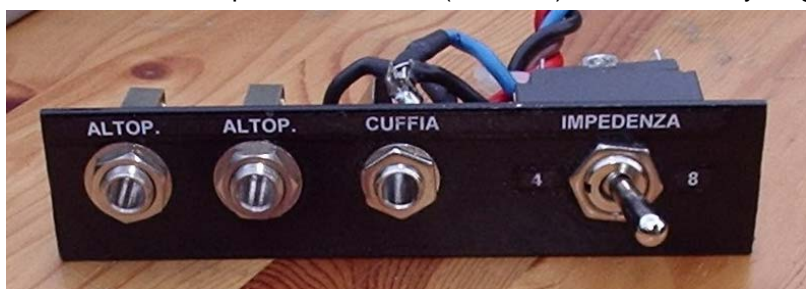
Having new transformers with 4-8-16 Ohm outputs that paralleled give the possibility of connecting 2-4-8 Ohm loudspeakers I decided to have a connector for phones (connected to the 2 Ohm output) and two jacks for loudspeakers connected to an impedance selector (4-8 Ohm). I installed everything on a panel to be screwed in the rear side.

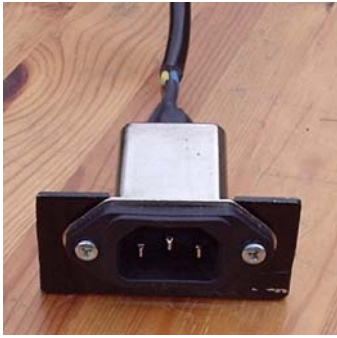
Another facility I added is the IEC connector. Not vintage at all, but safer and more comfortable than the original fixed cable. Moreover, I used one with an EMI filter inside to have a cleaner supply.

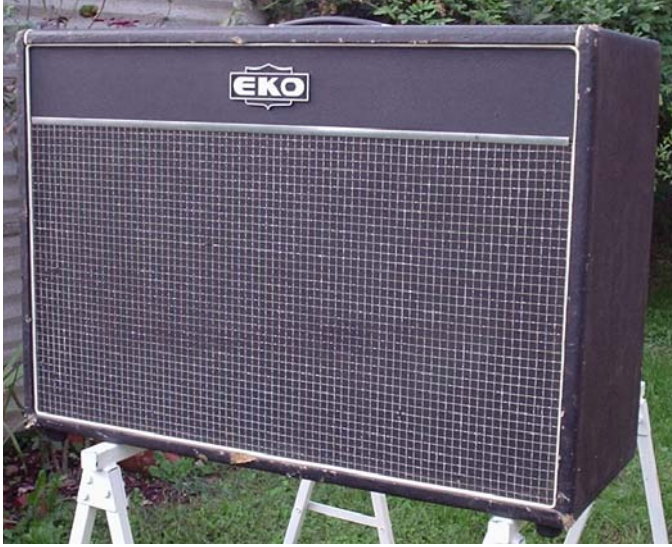
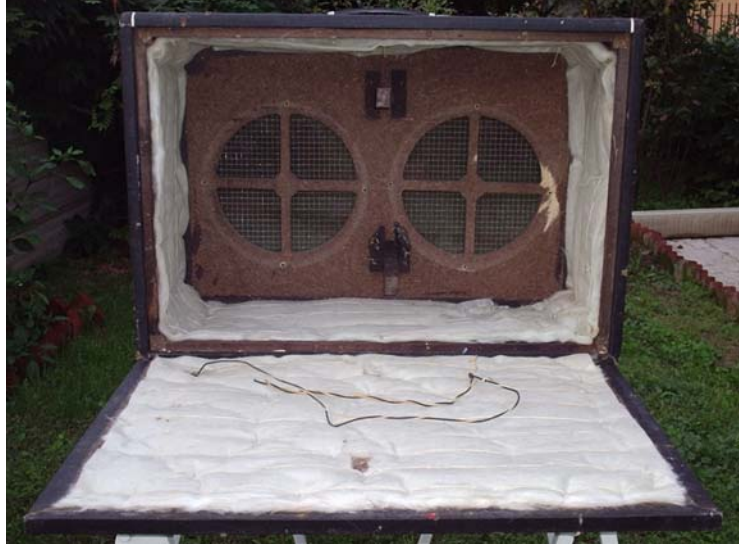
After 8 months of searches finally an ad came up: on sale a 2x12 Eko cabinet of the late sixties. I contacted the seller asking for photographs. Oh yes, it is the original one!!! It has only one loudspeaker and not original, it's a Jensen C12K. Well, not too bad, I already have two cones of the sixties waiting to be installed in a cabinet. Here it is when I received it.

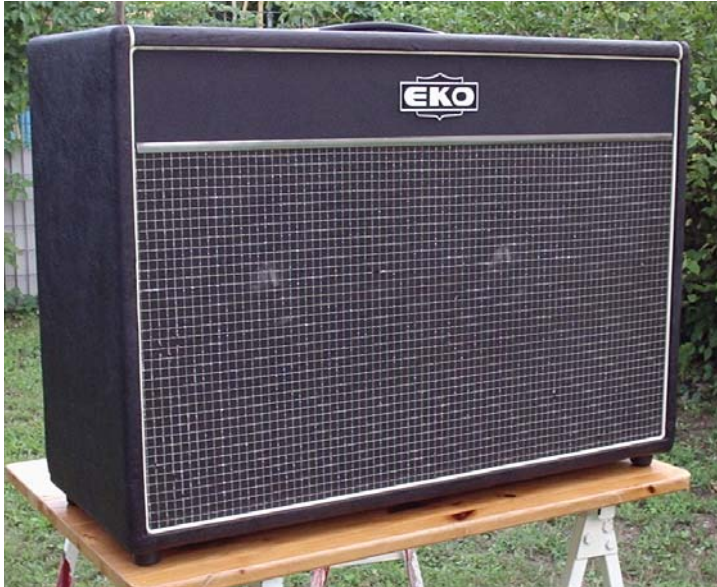
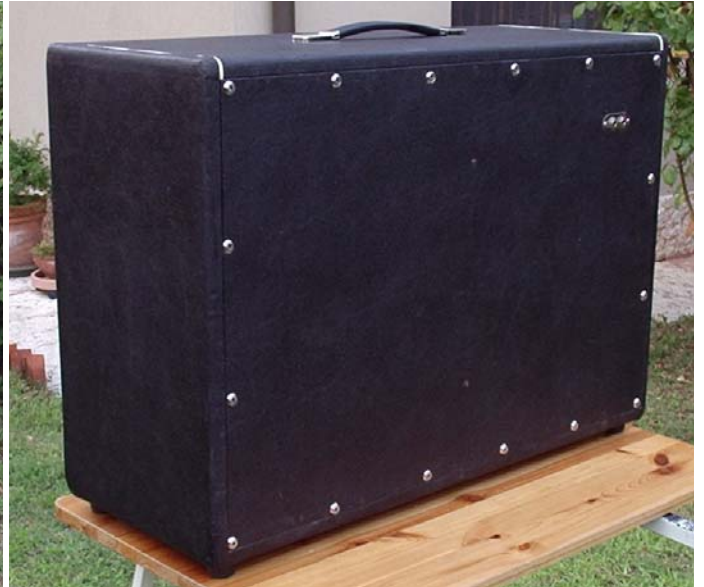
I removed the Jensen loudspeaker and installed mine. After a couple of days spent on restoring the tolex using some pieces cut from the one of the amplifier, new screws on the rear side, a new handle and here is the final result.

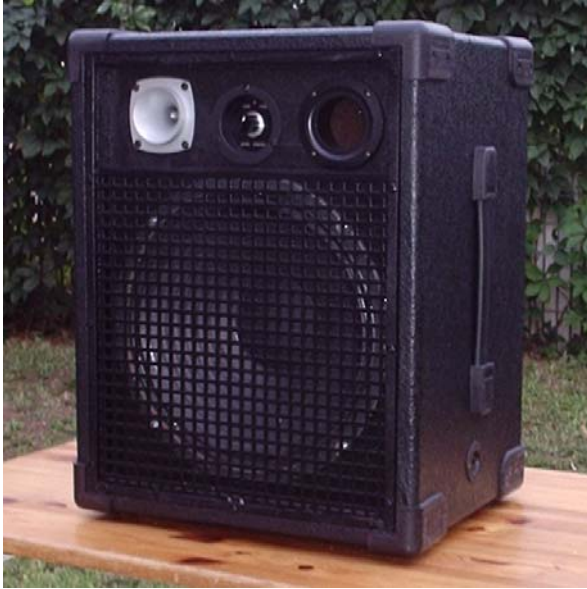
In the meantime something else happened. One day while parking my car near the office I saw a P.A. speaker case (only the cabinet, no cones nor the crossover network in it) laying on the ground. After 10 seconds it was in the trunk of my car. It was all painted with some sort of red paint that never dried and there was a rectangular hole on the top. Ugly indeed! Anyway, I took it home and began working on it. I removed all the corner protections, the handle and the jack plug. It took me a long time to remove the paint from the cabinet and from all the parts. The tolex was almost perfect, great! I only had to fix the hole and to cover it with some tolex. After three hours of work the cabinet was almost like new! During 2009 summer holidays a neighbor decided to clean up the cellar and gave me a pair of loudspeakers with a broken woofer. I didn't need the woofer, because it was too small (20 cm - 8"), but I used the crossover and the tweeter (a very nice one with aluminum horn). I drilled a hole for the bass reflex tube, I recovered the damping material from the loudspeakers and carefully fitted and fixed inside the cabinet, then I installed the crossover, the Jensen C12K woofer and the tweeter with its level control. I used a grill to protect the woofer. Here is the speaker for voice and/or acoustic guitar that cost me... €12,90 of paint thinner!

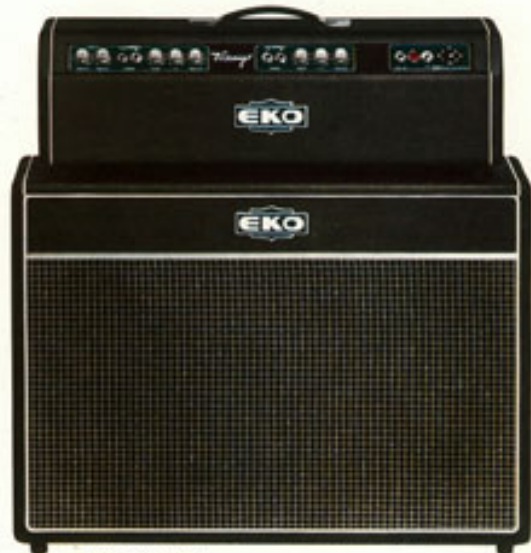
VISCOUNT REVERB Dual 12" professional speakers. Two channels with four inputs.

Channel 2: Pitched to normal guitar amplifier range. Two inputs, master volume control, high treble control, mid-range control, bass control. Output: 100 Watts - Piggy back construction.

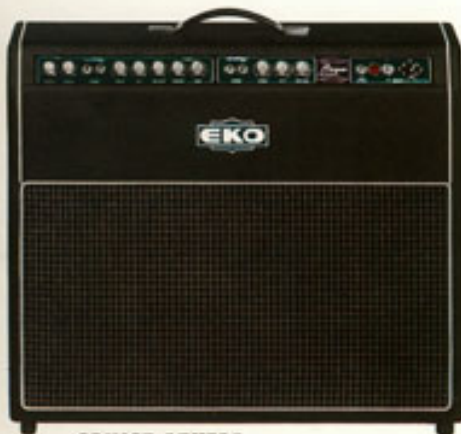
PRINCE REVERB Self contained guitar amplifier. One 12" professional speaker. Two channels with 4 inputs.

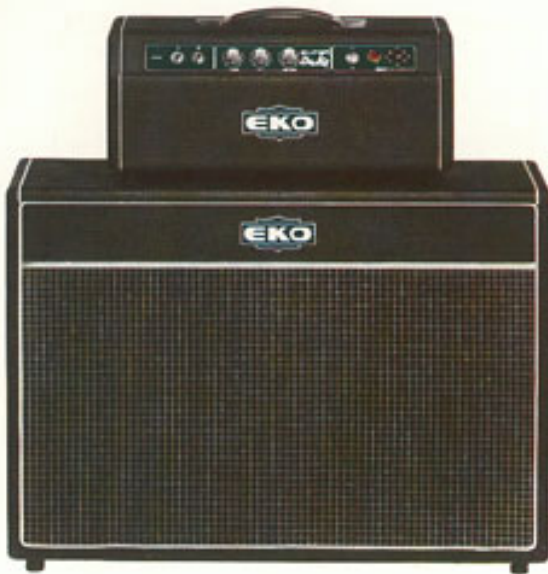
SUPER DUKE

Designed for electric bass and electronic organ.
Specifications: Two 12" heavy duty professional speakers. One channel with two inputs. Master volume control, high treble tone control, mid-range tone control, bass tone control. Output: 100 Watts. Piggy back design.

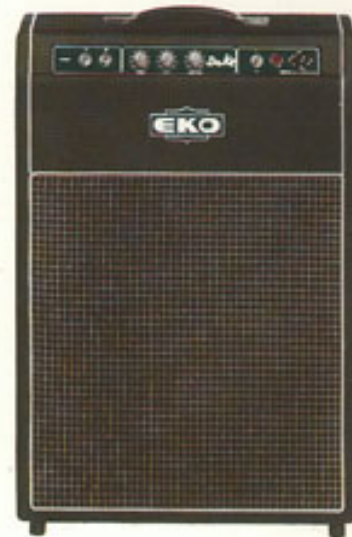
DUKE

Designed for electric bass and electronic organ. One 12" heavy duty professional speaker. One channel with two inputs. Master volume control, high treble tone control, mid-range tone control, bass tone control. Output: 50 Watts. Self contained.

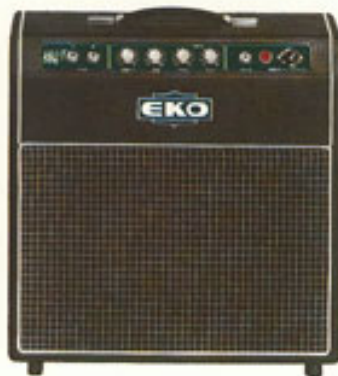
VALET

For guitar. One 10" Hi-Fi speaker. One channel, 2 inputs, volume control, tone control, vibrato intensity control and vibrato speed control. Input jack for vibrato foot switch. Output: 30 Watts.
